Noise and vibration
emerging methods

The 6th conference, 7 – 9 May 2018
Ibiza – Spain

A CASE STUDY OF DRIVELINE CLUNK NOISE AND DEVELOPMENT OF VISCOUS COUPLING

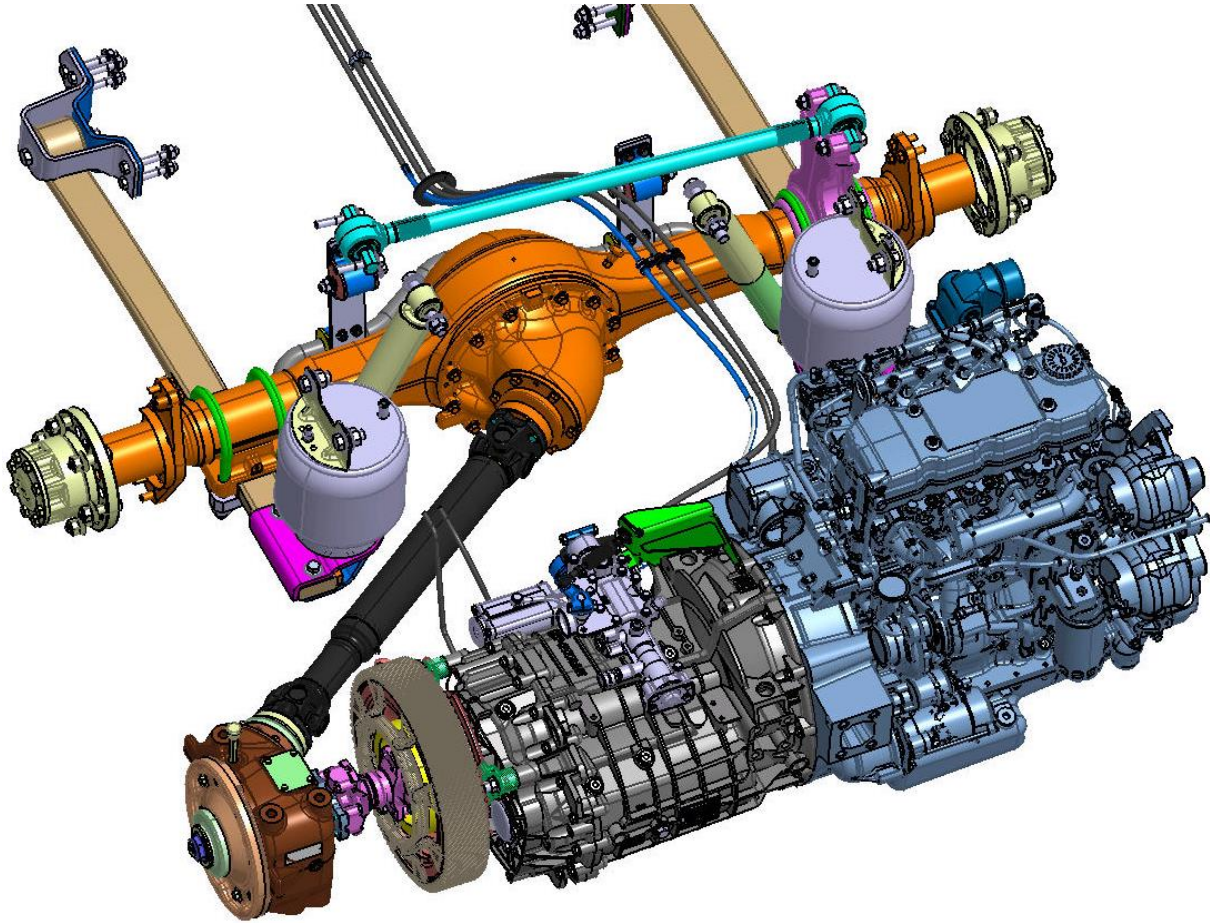
Figure 1: General View of Laterally Placed Powertrain and Driveline with Angle Drive.

Laterally placed powertrain with angle drive gearbox in driveline, shown in Figure 1, provides sufficient capability for an eight-meter length low-floor bus application. However, this placement and supplementary parts store additional potential energy caused sharp and uncontrolled oscillations in the driveline, when gas pedal is released especially during launch and parking manoeuvres. As the results of these oscillations in the driveline, customers are perceived vehicle fore-aft and clunk noise.

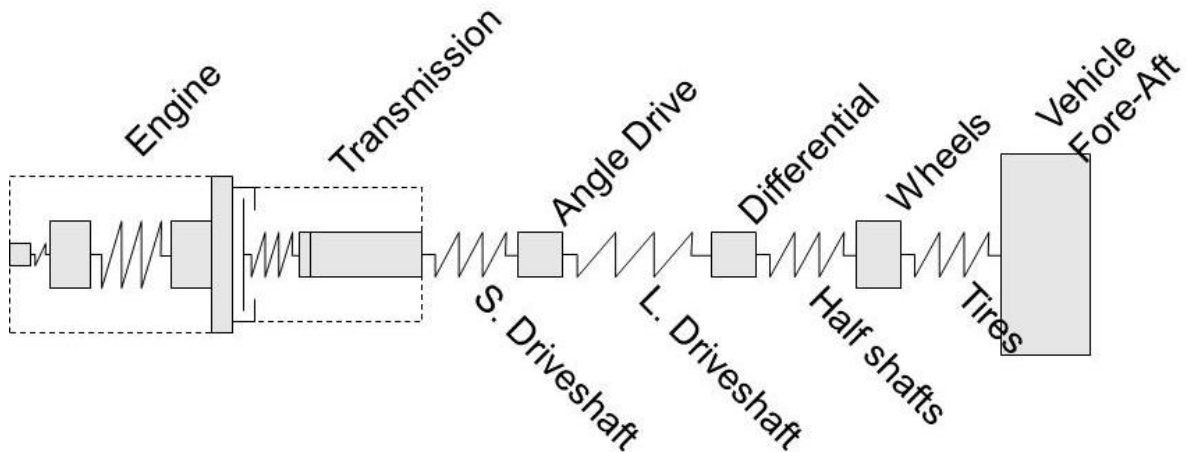
Figure 2: Torsional Representation of the Powertrain and Driveline.

As shown in Figure 2, the oscillations in the driveline (torsional modes of driveline), are the main source of the vehicle fore-aft. Due to serial connection in the driveline, these parts reduce the total stiffness which increases the necessary duration to balance when gas pedal is released during launch and parking manoeuvres. These oscillations also introduce the clunk noise due to the gear couple backlashes which are necessary for lubrication purposes and not to be locked.

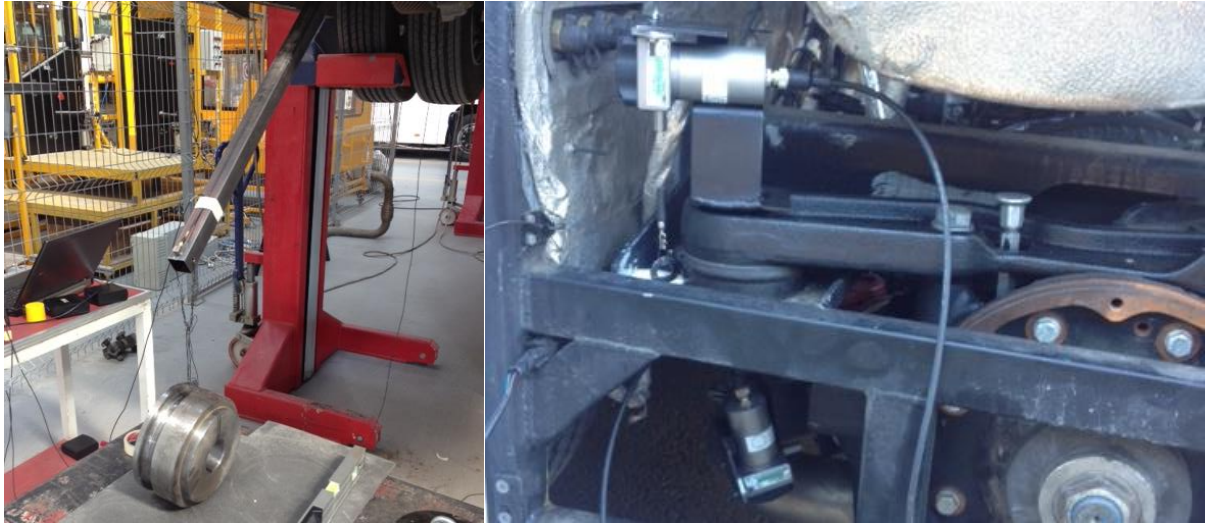
Figure 3: Driveline Backlash Measurement.

Driveline system backlash values are measured as shown in Figure 3 and Table 1. Static loaded and dynamic backlash values are higher than the vehicles with longitudinal placed powertrain. However, static backlash values are proper like longitudinal placed powertrain & driveline. This situation states that this driveline configuration is suitable to store potential energy. Therefore, clunk noise, caused by driveline oscillations, is appeared when gas pedal is released during launch and parking manoeuvres.

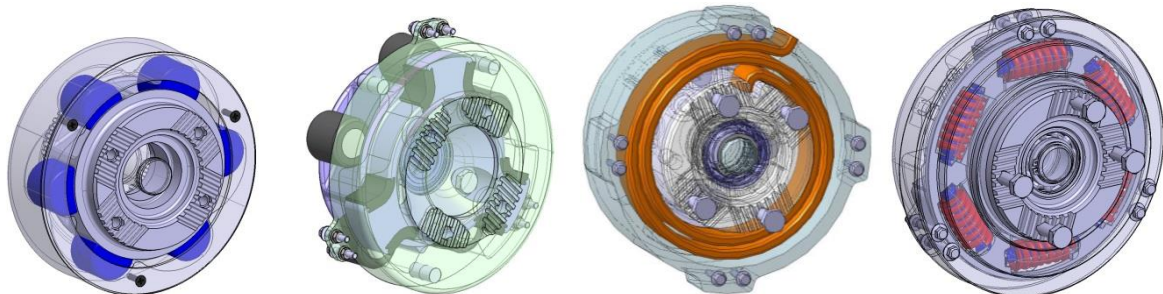
Figure 4: Designed Torsional (Flexible) Couplings.

The average & highest transferred torque values, packaging volume and backlashes prevent applying the ready-to-use torsional couplings. Therefore, torsional coupling designs are prepared in two concepts. The main difference between concepts is including rubber or coil as spring element as shown Figure 4.

Four different torsional (flexible) couplings are designed. First prototype is quite successful to reduce the clunk noise. However, rubber elements are failed in a short usage. Therefore, studies are concentrated on this solution by improving the rubber element

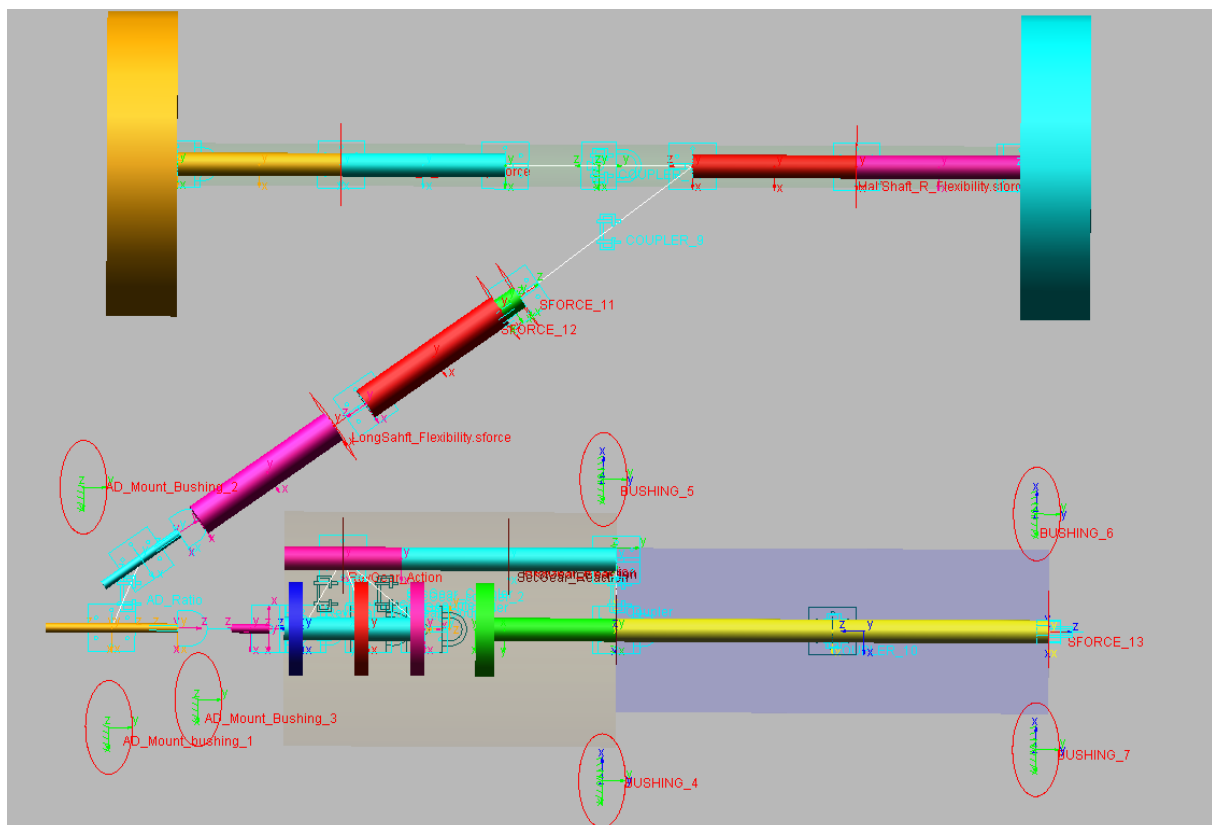
Figure 5: Driveline Kinematic Model.

Driveline kinematic model, shown in Figure 5, is prepared to understand damping necessity. Initially, oscillation durations of baseline status, between 5s and 6s during launch and parking manoeuvres, is evaluated. These results are also correlated with the tests, performed in the prototypes. According to achievements of primary prototype, damping value is examined and optimized in driveline kinematic model. Subsequently, oscillation durations, during launch and parking manoeuvres, are set between 2s and 3s. The amplitudes of forces, during the oscillations, are also decreased more than half.

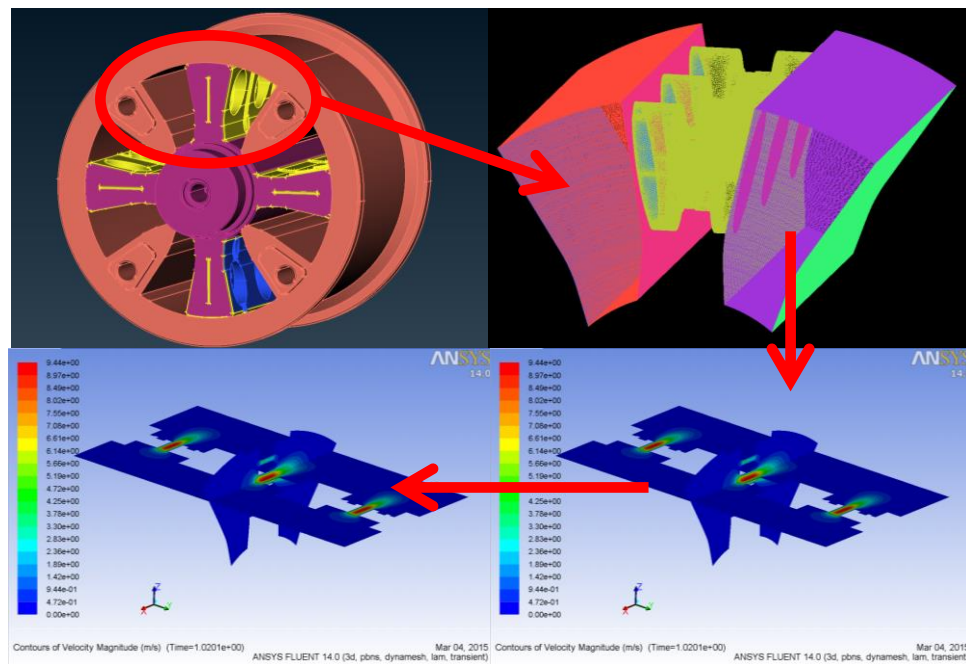
Figure 6: Viscous Coupling CFD Model & Analyses.

After finalizing of the damping value, CFD analyses are run to size the holes between rooms and the size of the rooms itself as shown in Figure 6. CFD analyses are also run to select the fluid viscosity inside the viscous coupling.

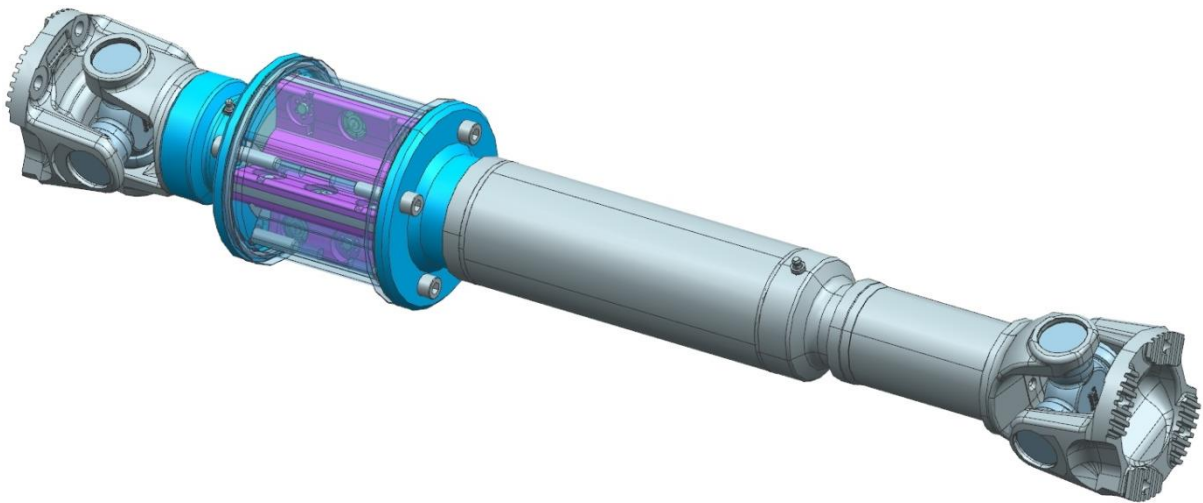
Figure 7: Long Drive Shaft with Viscous Coupling CAD Model.

As shown in Figure 7, after critical sizes of viscous coupling are defined, initial CAD model is prepared.

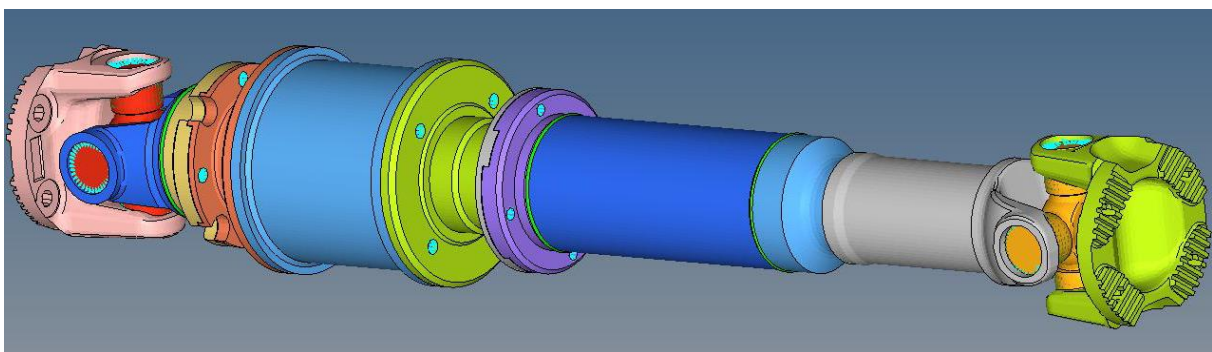
Figure 8: Long Drive Shaft with Viscous Coupling FE Model.

To understand the critic shaft revaluation speed, natural mode analyses are run as shown in Figure 8 and Figure 9. First natural mode frequency is equal to 174 Hz. Critic shaft revaluation speed is 5200 rpm accordingly. Theoretically maximum shaft revaluation speed during operation is equal to 4500 rpm. Therefore, there is no issue expected due to the critic shaft revaluation speed.

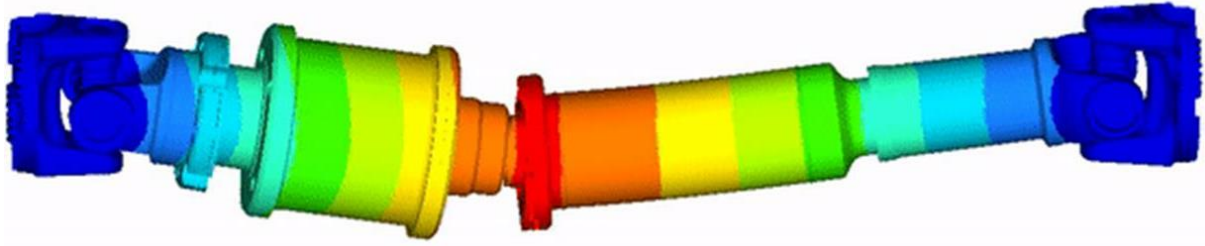
Figure 9: First Natural Mode of Long Drive Shaft with Viscous Coupling (174 Hz.).

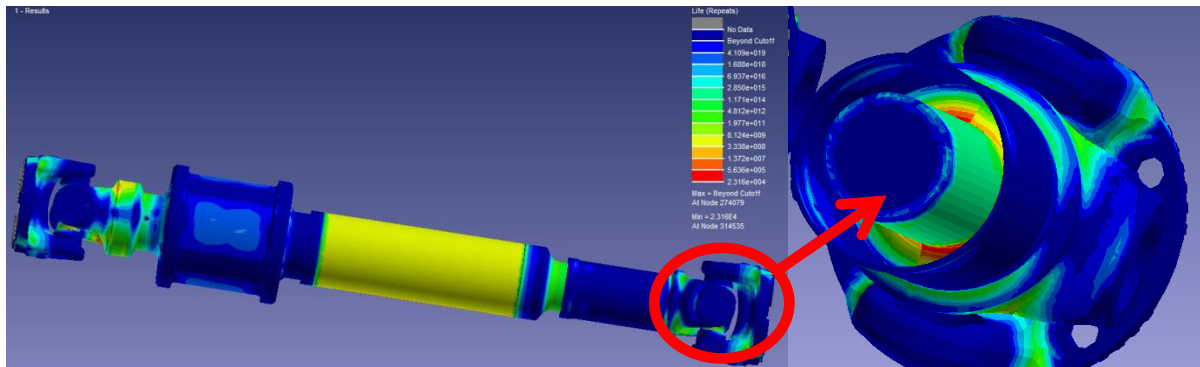
Figure 10: Static Loading Results of Long Drive Shaft with Viscous Coupling.

Viscous coupling satisfies all requirements in static loading with high safety factor in full torque loading scenario. In fatigue analyses, it also fulfils three times longer life according to expectations in all scenarios.

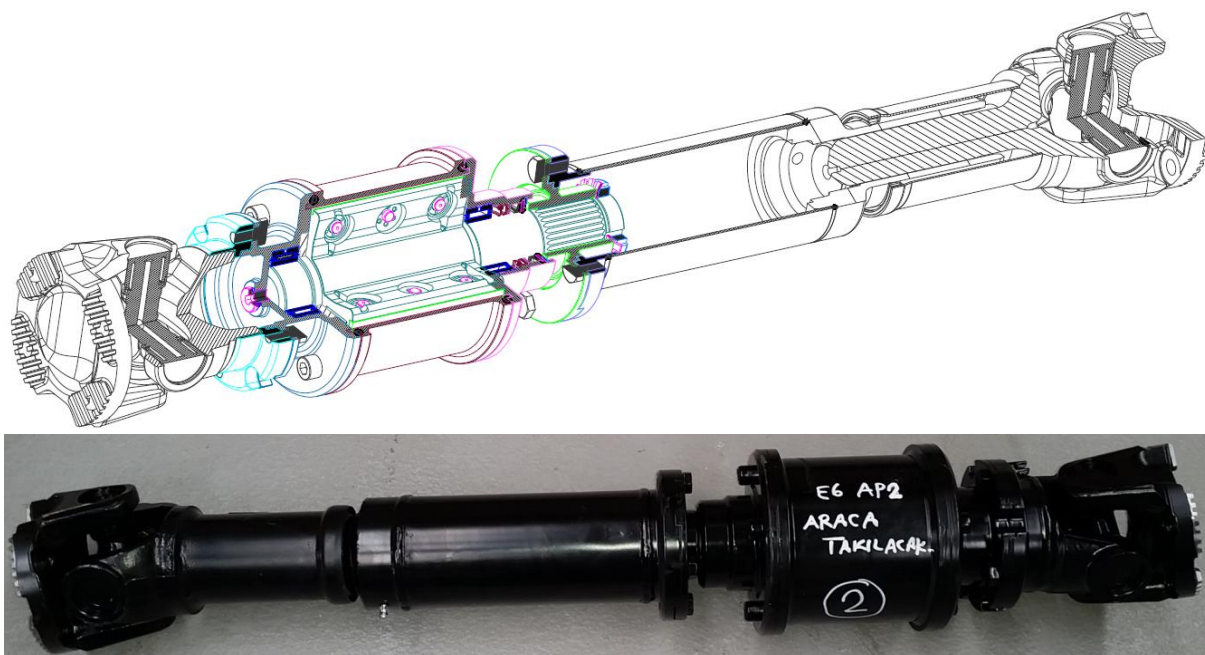
Figure 11: Production Drawing and Prototype of Long Drive Shaft with Viscous Coupling.

Prototypes are manufactured, as shown in Figure 11, for bench and on-vehicle tests. In order to correlate the natural mode analysis results, experimental modal analyses are performed as shown in Figure 12 and Figure 13. Frequency difference is less than 5 Hz in the first mode while the shape is the same. Durability bench test is also executed as shown Figure 14 and Figure 15.

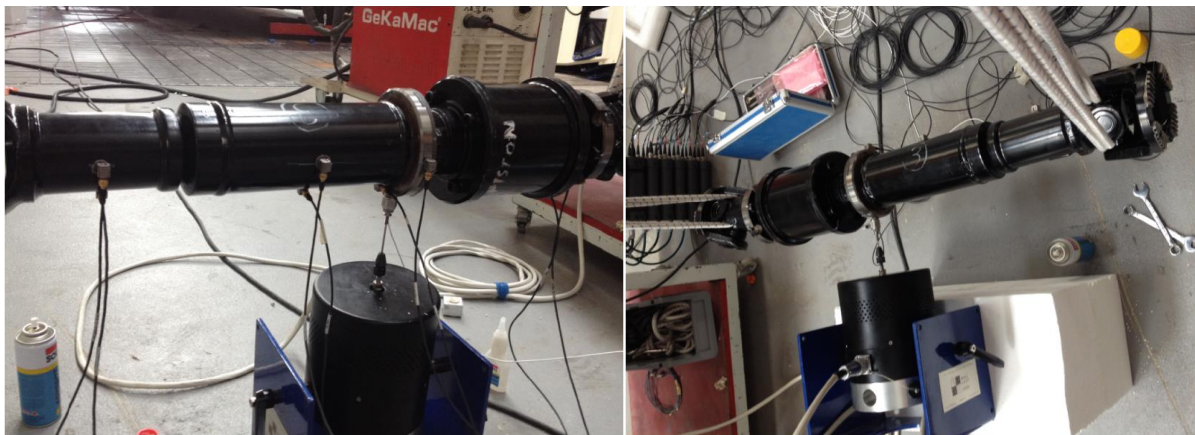
Figure 12: Production Drawing and Prototype of Long Drive Shaft with Viscous Coupling.

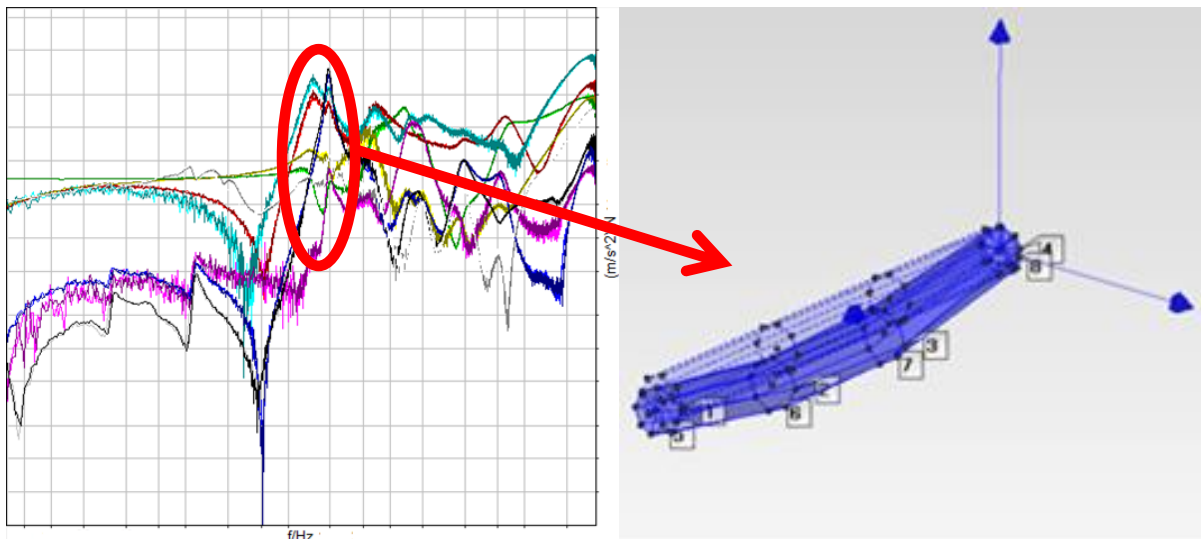
Figure 13: Results of Experimental Modal Analyses.

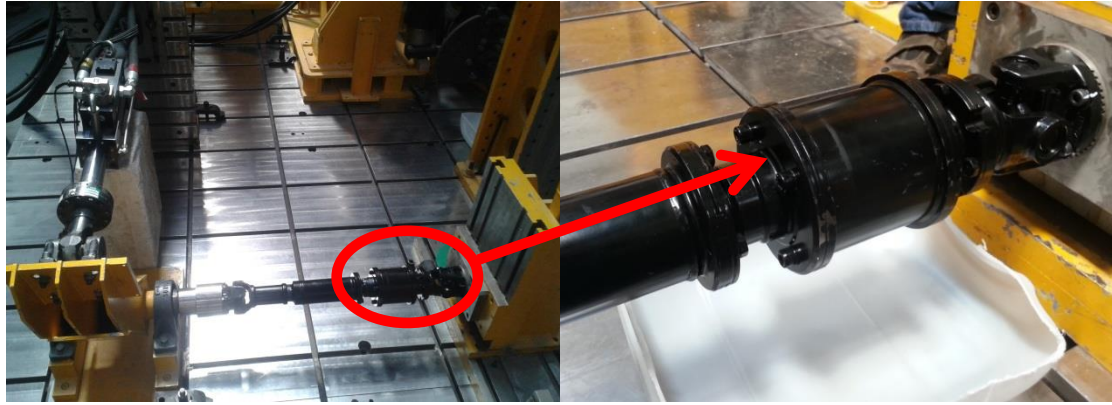
Figure 14: Durability Test Bench.

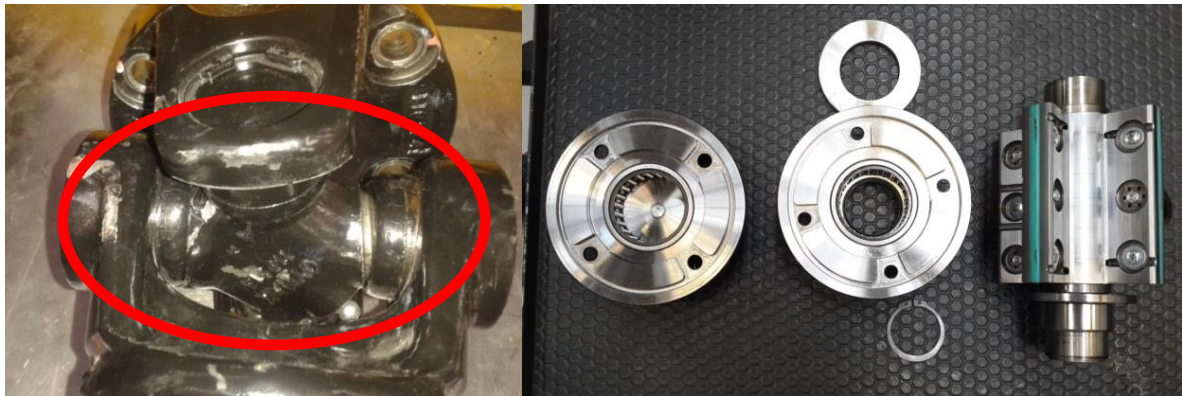
Figure 15: Broken Part and Viscous Coupling Parts after Durability Test.

The prototype of Long Drive Shaft with Viscous Coupling is also satisfied life expectations in durability test. Broken part in durability test and the point, in which highest stress is detected in FE analyses, are the same.

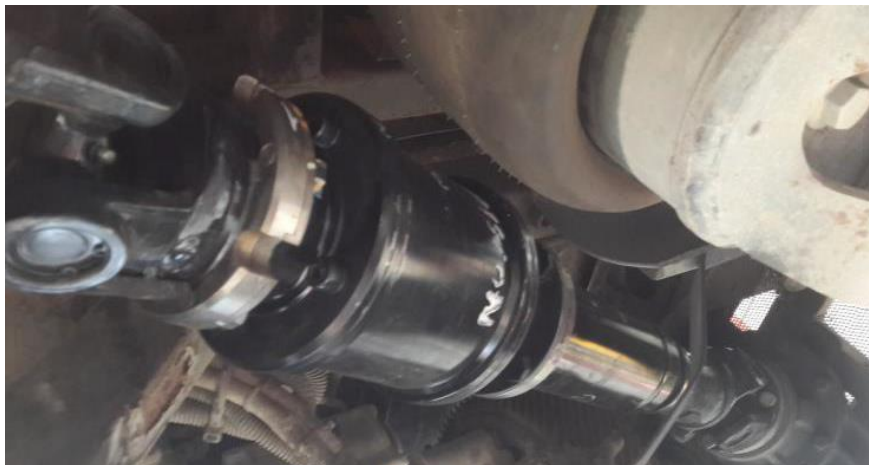
Figure 16: Vehicle Assembled Long Drive Shaft with Optimized Viscous Coupling.
